FIRE IN U.S. ARMY HELICOPTER ACCIDENTS

1 JULY 1957 THROUGH 30 JUNE 1965

By
Emil Spezia

Report No. HF 67-1

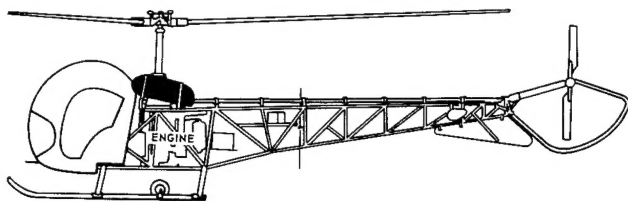
FIGURE 2

During the eight years this report covers, the fuel system of the OH-13G and H demonstrated the least resistance to failure during crashes. This observation helicopter, which has been one of the mainstays of Army operations, accounted for 38% of the survivable post-crash fire accidents. Its main design deficiency is the unprotected location of its twin fuel tanks (see Figure 2).

OH-13 Models G and H Twin Fuel Cells

The survivable fire accident rate of the OH-13G and H over the years has been five times that of the D and E. In 91% (32 of 35) of the survivable fire accidents shown on Table 3, fire was due to a rupture or puncture of the fuel tanks or fuel lines. Added fuel capacity, needed for the D and E to grow into the higher performing G and H, required larger tanks. The change resulted in the design decision to install twin tanks with a combined capacity of 43 gallons. This new location was needed for the enlarged tanks because it would least affect the helicopter's center of gravity (see Figure 2). The enlarged twin tanks in this location, saddled on each side of the rotor mast above the engine, crowded the available protective space the airframe gave to the D and E tank. Because of their enlarged size, the twin tanks were moved nearer the rotor mast and

were often punctured by the swash plate when the mast became displaced during a crash. Larger dimensions also caused the tanks to extend beyond the protection of the airframe, which makes them among the first parts of the aircraft to strike the ground. In the event of roll-over, which is characteristic of a helicopter accident, the twin tank configuration always leaves one tank atop to leak fuel. This point is illustrated by the following excerpts of statements given in two accidents:

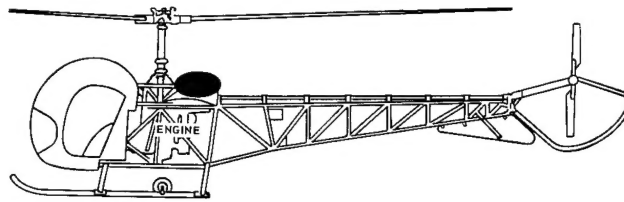
FIGURE 3

OH-13 Models D and E Single Fuel Cell

The reason for the OH-13D and E low rate, now that it can be compared with the G and H, is believed to be due to its single 29-gallon tank, mounted above the engine and aft of the rotor mast (see Figure 3). In this location, the tanks are relatively well protected from rupture and puncture damage. However, Table 3 shows that in five of its six fire accidents, either the tank or the adjoining fuel lines failed to prevent fuel spillage. This fact points out that this location is still not ideal, because, when fuel is spilled, it has quick access to the many ignition sources available about the engine.

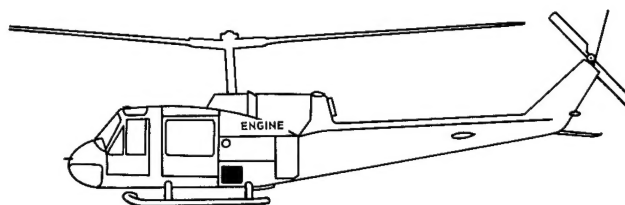
FIGURE 4

The earlier study gave an indication that because of the protective location of the UH-1A and B fuel cells (see Figure 4), these would be expected to

UH-1 Models A and B Bladder-Type Fuel Cells Aft of Cockpit

earn a low fire accident rate. The UH-1A and B experience of FY 64-65 shows the lowest rate of all models at 1.1/100,000 flying hours. In its seven survivable fire accidents, the fuel tanks neither ruptured nor punctured. They remained intact and no fuel was spilled.

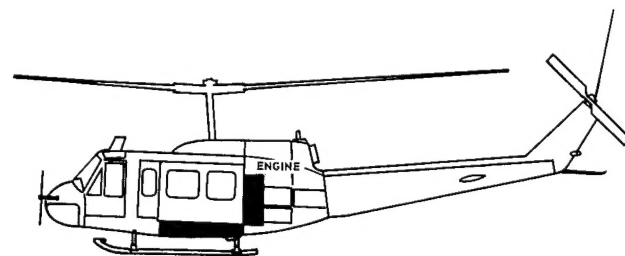
FIGURE 5

UH-1D Model Added Cells Aft of Cockpit

The record of the UH-1D which has a larger fuel capacity than the A and B, shows that the cells remained intact in four of its five survivable fire accidents. In the one accident,¹⁰ leaking fuel from the ruptured tank did not get involved in the fire. The engine fire that erupted was put out with portable fire extinguishers before the fuel from the ruptured tank was reached. The UH-1D rate indicated in Table 2 of 4.9/100,000 flying hours is attributed to engine malfunction, the electrical system, and transmission oil system. The fuel system was indicted for the cause of one because of the improper design of its vent system.

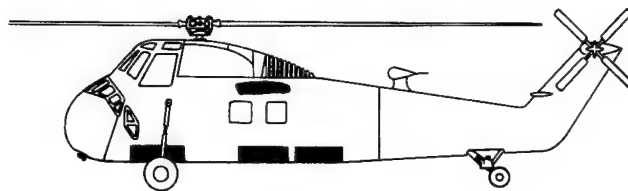
FIGURE 6

cells. The fuel cells, located below the fuselage floor, are susceptible to puncture upon impact and the near proximity of the forward fuel cell to the engine compartment. Each of these features, examples of inadequate crash-fire-design, are apparent in the following briefs:

CH-34 With Three Fuel Cells in the Belly of the Helicopter

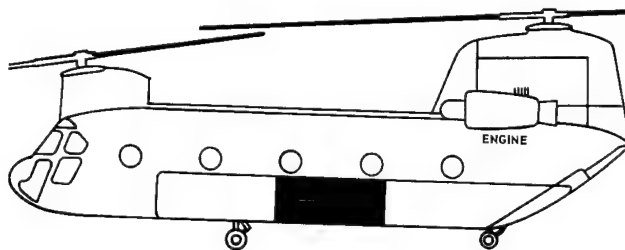
FIGURE 7

Similar design practices are found in the UH-19, CH-21, and CH-47. In the Chinook (CH-47), however, this combination of features is somewhat better (see Figure 7). The fuel cells, though located below floor level, can be penetrated by the rear landing gear, but are some distance from the engines which are mounted on each side of the aft rotor pylon.

CH-47 Fuel Cells Remote From Engine Area

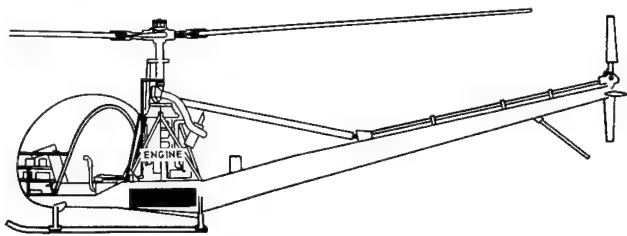
FIGURE 8

OH-23 Single Bladder-Type Fuel Cell

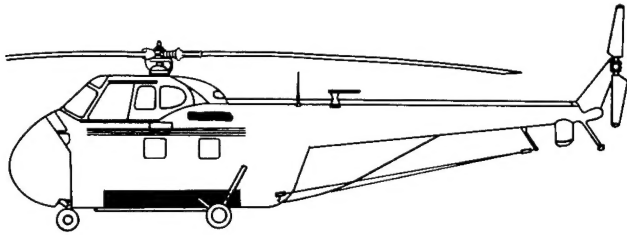
FIGURE 9

UH-19 Fuel Cell Location in Relation
to Landing Gear and Engine Area

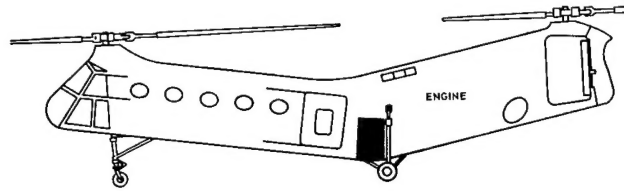
FIGURE 10

CH-21 in Relation to Landing Gear
Fuel Cell Location and Engine Area
